NUMBER: 23-001-09

Rust And Or Corrosion On Quarter Panel Above Taillamp.

2008 (VB) Sprinter Wagon and Van (2500)

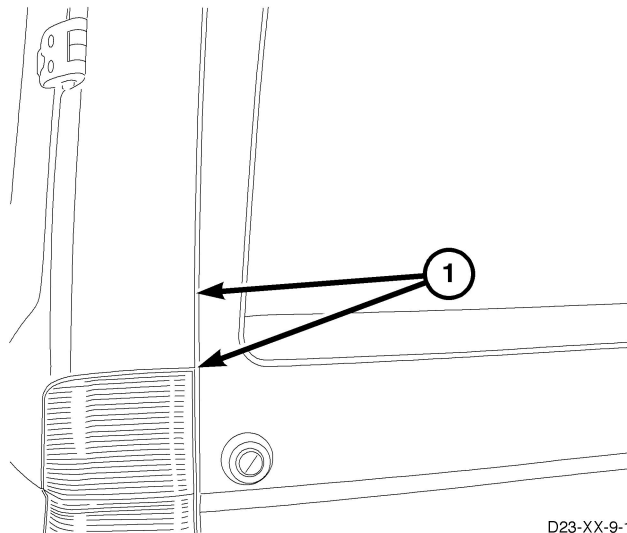
Fig. 1 Rear Quarter Panel

Some vehicles may exhibit a void on the quarter panel(s) above the taillamp(s). Further investigation by the technician may find the sealant is missing with a possibility of corrosion in the void.

1 - Sealant Location and possible rust.

1. Clean with Mopar Car Wash Concentrate, and water.
2. Dry thoroughly.
3. Wipe with wax and grease remover.
4. Inspect for rust in the areas shown in (Fig. 1).
5. If rust has been identified refer to procedure "B" otherwise continue.
6. Remove Taillamp. Remove Lower Splash Shield. Refer to the detailed removal and installation procedures available in DealerConnect> TechCONNECT under: Service info > Electrical> Lamps and Lighting> Lamps/Lighting Exterior> Lamp, Turn Stop Turn> Removal> Lamp- VAN AND WAGON.
7. Mask off the void as close to the edge as possible.
8. Sand the void lightly with a Red Scuff Pad or equivalent.
9. Clean with Wax and Grease Remover
10. Apply Sika 221 - Sealant, Black, 3M #08609 Urethane, Windshield or equivalent per manufacturers recommendations (Fig. 1)

6. If the corrosion extends under the sealant, remove sealant to a point which is 2" beyond any corrosion.
7. Mask off the void as close to the edge as possible.

8. Remove rust using 220 grit sandpaper.
9. Apply IES Rust Raider #1840 or equivalent.
10. Light scuff with Red Scuff Pad or equivalent.
11. Remove sanded or torn masking tape.

17. Apply Sika 221 - Sealant, Black, 3M #08609 Urethane, Windshield or equivalent per manufacturers recommendations (Fig. 1)
18. Remove masking tape.
19. Install Taillamp. Refer to the detailed removal and installation procedures available in DealerConnect> TechCONNECT under: Service info > Electrical> Lamps and Lighting> Lamps/Lighting Exterior> Lamp, Turn Stop Turn> Removal> Lamp- VAN AND WAGON.
